Rural Stop-Sign Controlled Intersection Crash Avoidance System Device

Engineering District 10-0
Intelligent Transportation System Review

Rural Stop-Sign Controlled Intersection
Crash Avoidance System Device

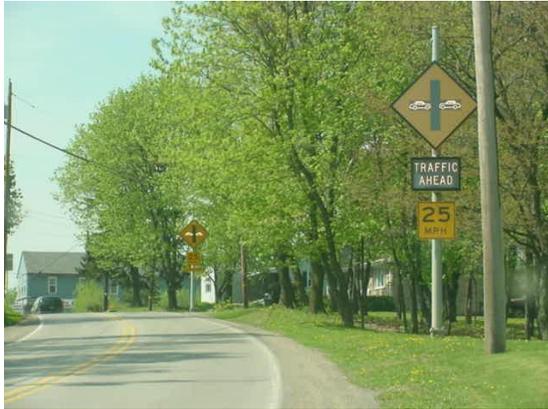
Figure 1 - Major Leg CAS Sign
S.R. 38 and S.R. 1010 Southbound

intersection. Drivers approaching the intersection from all directions are graphically advised of the presence and direction of approaching intersection traffic. Figures 1 and 2 depict signs applied at the major and minor legs, respectively.

The northbound approach to **intersection a** has an standard intersection sign with an advisory speed of 35 M.P.H. located at 750' followed by an ITS controlled illuminated sign at 450' and a final ITS controlled illuminated sign 200' prior to the intersection. The southbound approach has a standard intersection sign with an advisory speed of 35 M.P.H. located at 750' followed by an ITS controlled illuminated sign at 500' and a final ITS controlled illuminated sign 300' prior to the intersection. Figure 1 demonstrates the general placement of signing as you approach both of the intersections.

when traffic is approaching the intersection from all four legs. The major leg approach depicts when vehicles are entering the intersection. The minor leg shows vehicles approaching the intersection, which warns motorists not to traverse through the intersection.

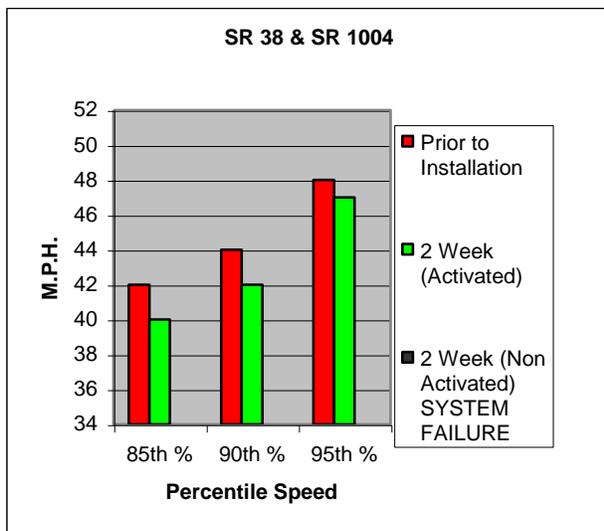
Graph 1
Percentile Speed Comparison
Two-week

The following charts represent the above table in graphical format:

The following chart and graphs represent the overall percentile speeds for vehicles traveling through the intersection. The speeds are compared to

pre- and post-installation and while the CAS system is activated and not activated. The majority of the speed through the intersection while the CAS system is activated and non-activated decreased.
