# Collision Avoidance System

## Evaluation Report

January 2007

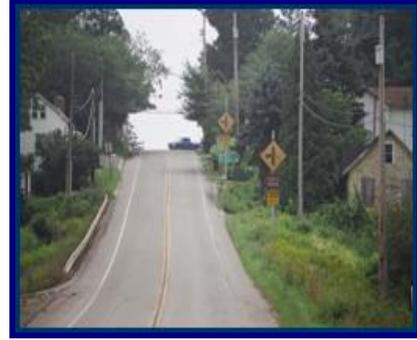
SR 38 Sign with Illuminated Indications

Each intersection is configured the same, using inductive loop detectors to transmit a signal to a controller that in-turn transmits a message to activate either the mainline signs or the side street signs. The inductive presence loops located at the intersection are 5 feet wide and 40 feet long except for the southbound approach at Hooker which has a 50 foot long inductive loop. There are also pulse loops installed prior to each SR 38 approach that calculate speeds and identify traffic. [Construction drawings](#), the [Operators Manual](#) and the [equipment cabinet configuration](#) are available in the Appendix.

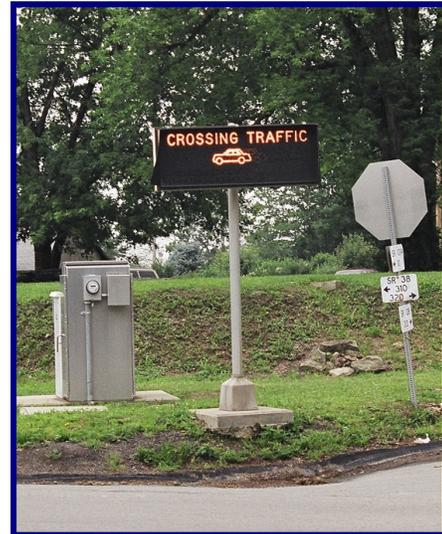
Side Street Sign Indication. This display indicates that a vehicle is approaching from the right.

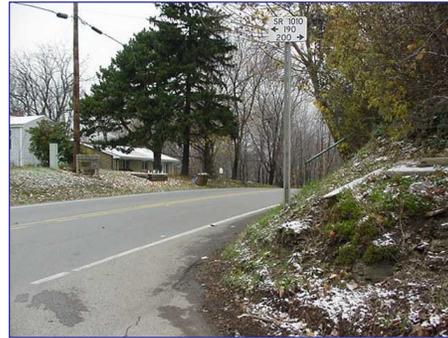
**View of Sight Distance Restriction for Westbound Hooker Road Looking North**
