**AUTONOMOUS MONITORING STATION PILOT PROJECT  
USING DIGITAL PCS (1XRTT) DATA NETWORK**

**ENTERPRISE  
Ontario Ministry of Transportation  
Transportation Development Centre of Transport Canada**

**October 2006**

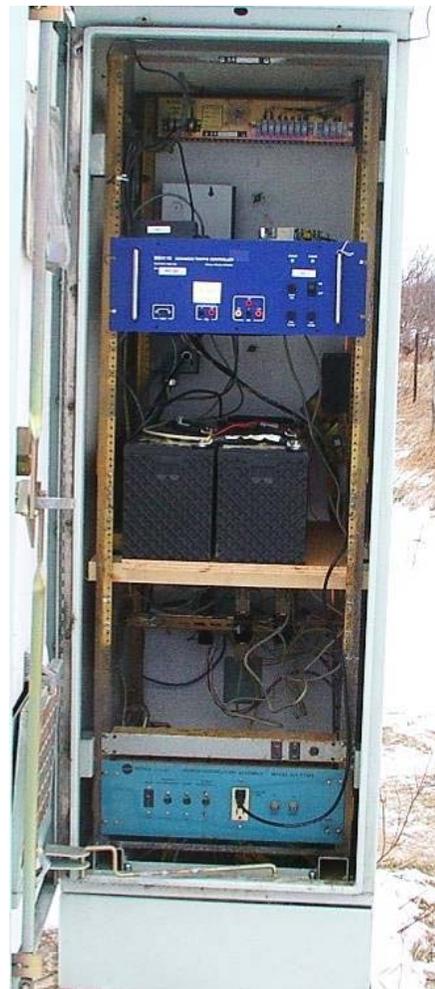
Figure 2-2 ATC and Cabinet

The ATCs are equipped with 3 serial ports and one 10-BaseT Ethernet interface. The visibility sensors and the RTMS traffic detectors were specified to provide their sensor data through ASCII protocols over a standard serial interface with the camera connected via the Ethernet interface. This serial arrangement simplified the overall sensor integration effort.

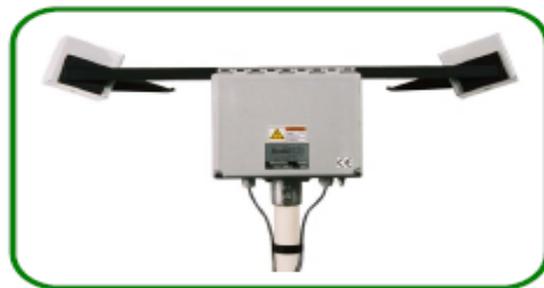
Figure 2-3 Visibility Sensor

The visibility sensor works on the principle of forward scattering. The design uses an active transmitter and an opposing receiver mounted at 42 degrees looking forward at a sample volume of air in front of the sensor arrangement. The emitter transmits infrared light into the sample volume and the detector receives any light that is scattered by any contaminants within the sample volume such as smoke, dust, haze, fog, rain and snow. The intensity of the signal is correlated to the extinction properties of the air sample. The sample volume is representative of the surrounding air near the sensor and therefore the sensor measures the extinction coefficient of the air and calculates the meteorological optical range (MOR) or visibility. The sensor electronics monitor MOR and produce an average "equivalent visibility" reading in meters every minute.

performance in varying weather conditions. Hood heaters are provided for both the transmitter and the receiver heads. To reduce the power consumption of the visibility sensor the hood heaters are wired to the ATC digital I/O and are manually controlled.

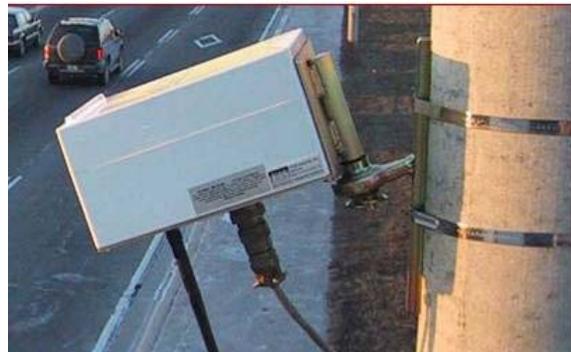
The RTMS traffic detector operates on the principal of ranging radar. The detector is an active device which emits pulses of microwave energy and receives the reflected pulses. The unit measures the time difference between the emitted and the received signal and determines the likely position of the vehicle. In the cross fired configuration, where the beam of microwave energy is directed across the road and all its lanes, the position of the vehicle corresponds to a particular lane. The detector determines the presence of a vehicle in the appropriate position (lane). For the AMS installation on Highway 21 the RTMS units are configured in the cross fired mode looking across both lanes of traffic. The RTMS unit uses some signal processing to derive the traffic data such as volume, occupancy and speed on a lane by lane basis.

Figure 2-4 Traffic Detector

The detector is mounted on a pole adjacent to the roadway. The mounting restrictions in this case are as follows:

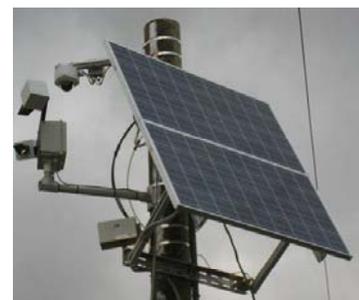
Figure 2-6 Solar Planes and Pole Mounted

The solar system consists of four solar panels, four deep discharge batteries and a solar control unit. The solar

control unit controls the battery charging rate to maximize the use of available sunlight. Through the duration of the demonstration, in spite of major snow storms and snow covered panels the system operated without a failure of the solar power system.

All sensors and solar collector equipment is pole mounted. The sensors were designed to be pole mounted and were delivered with the mounting details suitable for this arrangement. The four solar panels required to be broken up into two groups to be mounted on the same pole. The only item that required a special or custom mounting bracket was the CCTV camera. The dome camera required to be hung upside down away from the side of the pole.

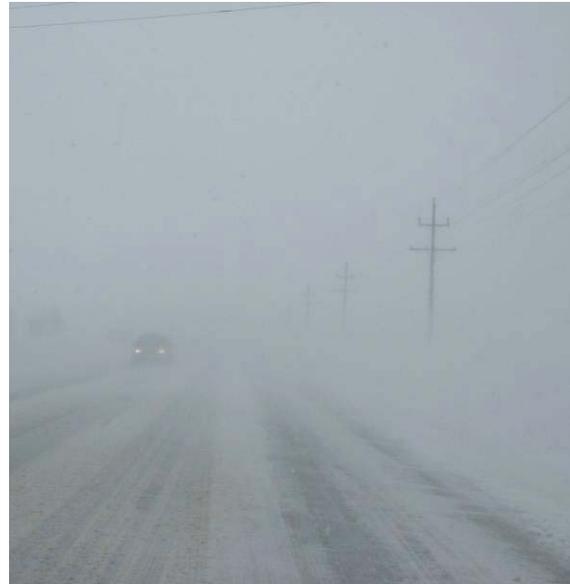
Figure 3-2 Hwy 21 taken on November 2005

Highways in this area suffer from heavy winds and snow squalls coming off Lake Huron which cause frequent white out conditions as illustrated in the photograph in Figure 3-2 taken in November 2005 along Hwy 21.

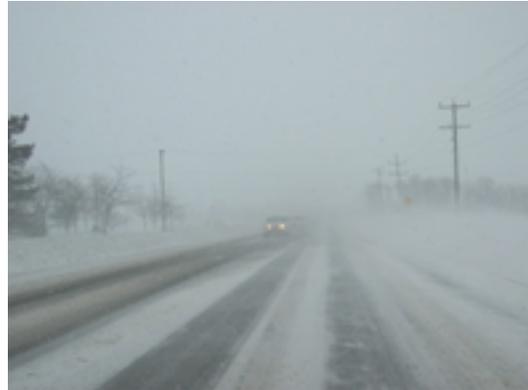
**Figure 4-2 December 21, 2005**

Figures 4-1 to 4-5 show photos taken during a field visit on December 21, 2005, between 11:40 a.m. and 12:45 p.m.. It was observed that visibility was poor or nil when passing through drifted sections, at driver's level. For example, Figure 4-4 shows that the lower part of the departing vehicle was about 2 hydro poles away, which is equivalent to about 100 meters.

- Second, experienced field operations observers may have gotten used to the harsh conditions along highway 21. This was somewhat confirmed during field visiting on December 21, 2005. Figures 4-1 to 4-5 show what could appear to be difficult driving conditions in the opinion of many less experienced drivers. Sensors reported 500 to 700 m visibility readings. Yet, on site, local MTO representatives reported the situation not too severe at that point in time. As we will see later in this report, vehicle speed data at these particular time do not automatically show significant immediate reductions, as though local drivers also felt somewhat comfortable with driving

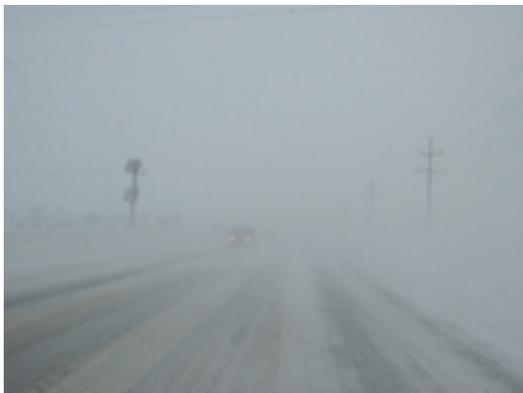
**Figure 4-3 Dec 21, looking south while  
a car approaches site 1  
(left side of the Photo);  
hydro poles visibles**

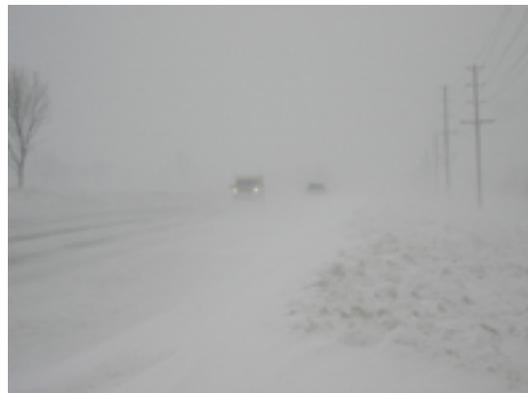
**Figure 4-4 December 21, 2005,  
12:34 near site 3, looking south**

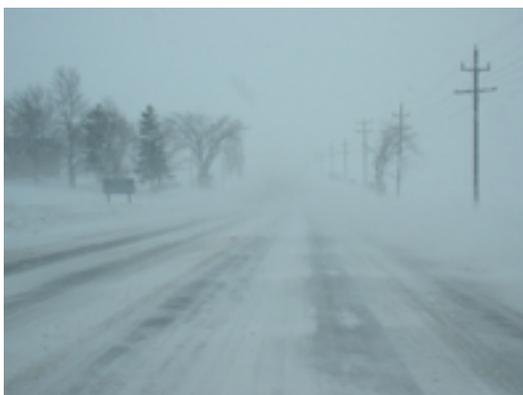
**Figure 4-5 December 21, 2005**

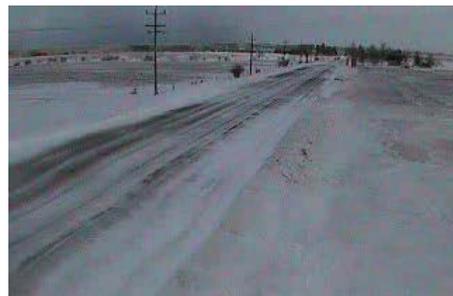
Figure 4-6 Feb 17, 2006  
at 12 :13 p.m.

Sometimes, speed dropped independently of reduction in visibility. As shown in **Appendix A – Chart 4.9**, between 6:30 and 16:45 on February 16 (road closed at 6:15 on February 17), average speed dropped to about 95 km/h but average visibility remained at ‘9999’. Factors other than visibility may have caused the speed drop, such as road conditions, drifting snow, as shown on Feb 17<sup>th</sup> video image or accidents.

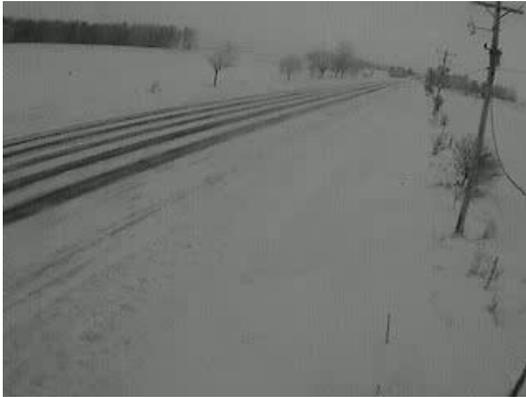
- As the worst part of this event occurred mostly during the night, the only images available were taken prior to the highway closure on the 24<sup>th</sup>. At that time, the roadway appeared partially snow-covered and wet.

Figure 4-9 Jan 24, 2006 at 12:15

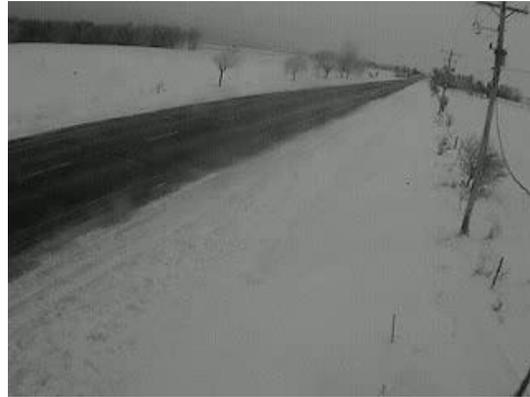
Figure 4-10 Jan 24, 2006 at 14:09

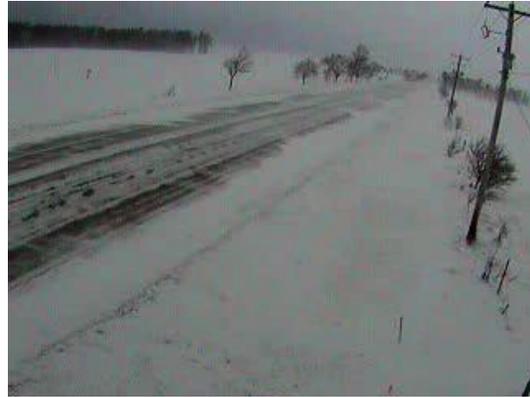
Images for the morning of Feb 6 and throughout the day show a roadway well-covered with patches of snow and ice and snow drifts along both sides of the highway, a sign of drifting snow at road level.

Figure 4-12 Feb 6, 2006 at 07:40

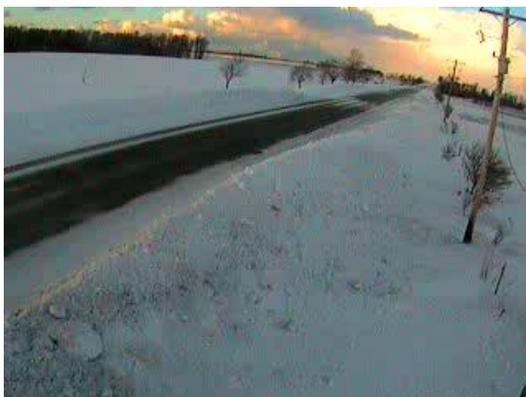
Figure 4-19 Feb 25, 2006 at 17:35

These conditions can be inferred from available images prior to closure on the 25<sup>th</sup> and early in the morning of the 26<sup>th</sup>. During the late afternoon of the 25<sup>th</sup>, wind-driven snow rapidly covered the roadway within 30 minutes (17:35-17:58). As winds increased that evening, more snow was added as the first available image the following morning confirms. A combination of bad weather and pavement conditions played a key role in the decision of field personnel to temporarily close HW 21.

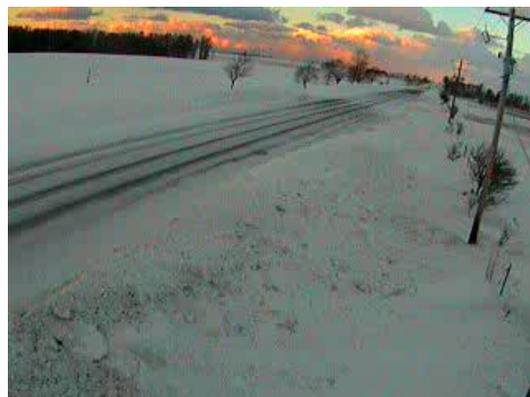
Figure 4-20 Feb 25, 2006 at 17:58

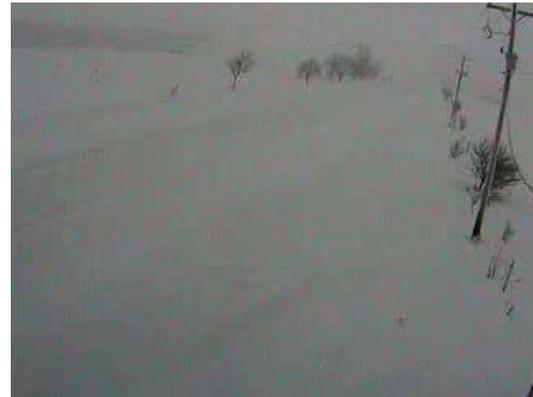
Figure 4-26 Feb 18, 2006 at 10:32

Images for that period show fair to poor visibility at 10:32 (similar to image at 06:58 in section 4.5.2 of the text, in reference to closures 4 and 5) with a clear distinction of better visibility conditions observed at 12:29. Throughout that period, the roadway appears seriously snow covered. The RWIS system at Amberley reported a snow warning in effect until the evening of the 18th. Perhaps driving conditions had been evaluated in the field as having improved so much from the previous worst episodes that field personnel felt comfortable reopening the highway. Consequently, the index would have kept field personnel online and proved a relevant

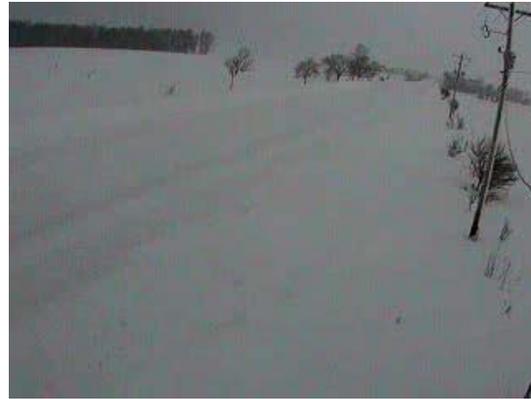
**Figure 4-27 Feb 18, 2006 at 12:29**

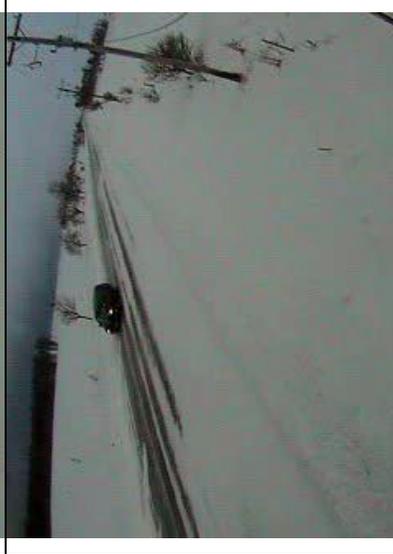
Heavy snow; blowing northerly
02/13/2006	07:53	Daylight	1	6769	150

Heavy snow; blowing northerly

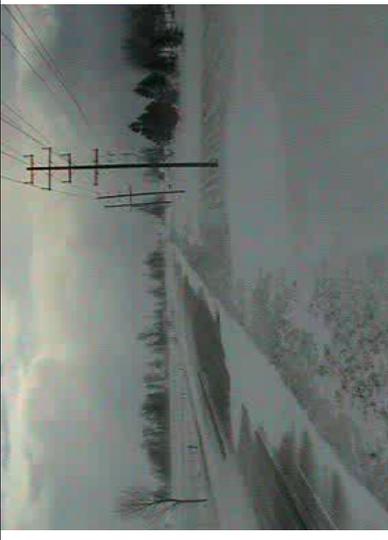
Date	Time	Natural light conditions	Station	Visibility sensor (m)	OPP/MTO (1 pole ~ 50 m)	Video	Comments
02/17/2006	14:25	Daylight	3	451	clear

Road just opened
02/17/2006	14:25	Daylight	2	2213	clear

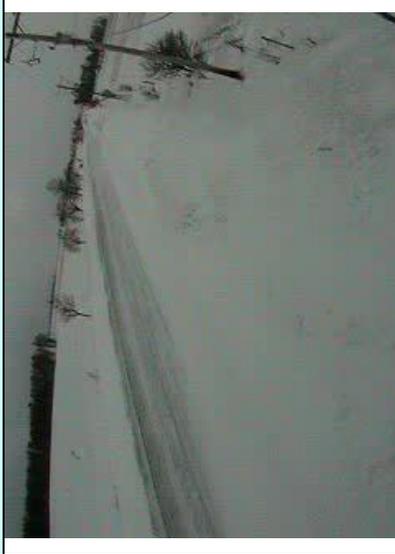
Date	Time	Natural light conditions	Station	Visibility sensor (m)	OPP/MTO (1 pole ~ 50 m)	Video	Comments
02/17/2006	14:25	Daylight	1	2305	clear

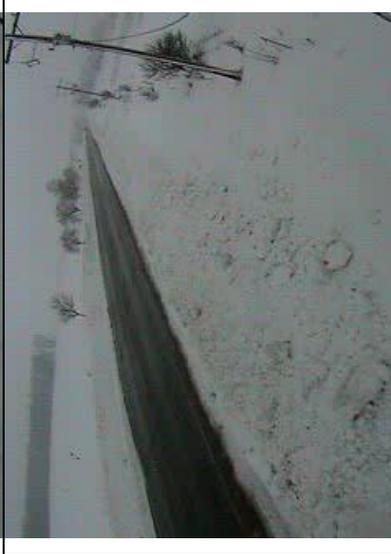
02/23/2006	13:35	Daylight	3	9999	150

Heavy snow, strong SW wind, slippery, wet, slushy

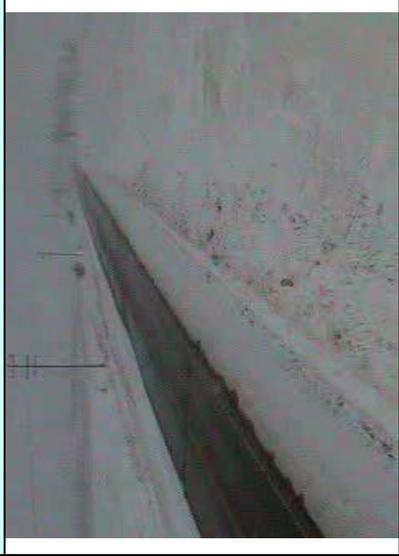
Date	Time	Natural light conditions	Station	Visibility sensor (m)	OPP/MTO (1 pole ~ 50 m)	Video	Comments
02/23/2006	13:35	Daylight	2	469	150

Heavy snow, strong SW wind, slippery, wet, slushy
02/23/2006	13:35	Daylight	1	542000	150
